Date: October 23, 2006

Subject: Earthquake Emergency Response Visit at Hapuna Beach State
Recreation Area
Big Island, Hawaii

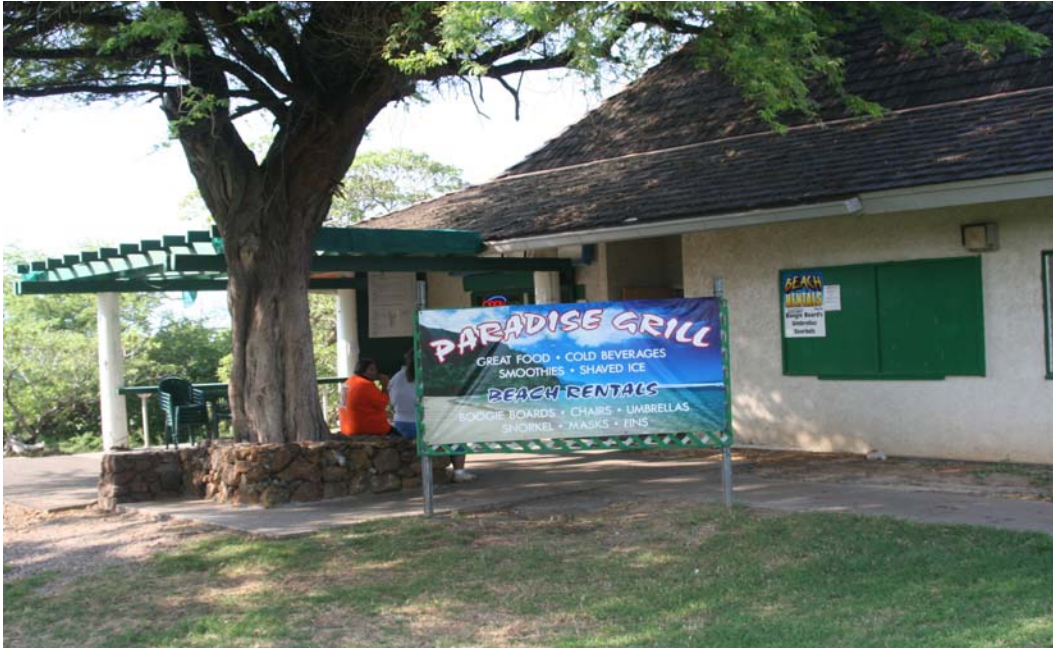
Photo No. 1- Paradise Grill Building at the State Recreation Area.

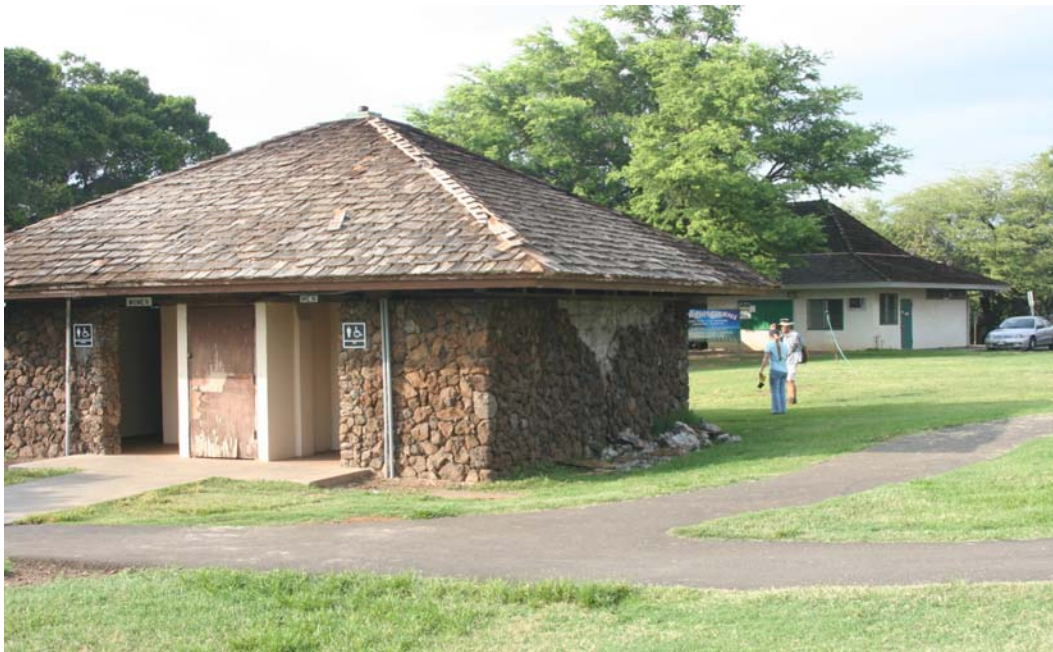
The park is located in a pristine costal area equipped with a number of restroom structures and resting/ shelters. An examination of one of the upper restroom buildings revealed areas of damage in the rock wall venire at least on two sides of the building. See Photo No. 2 through 4. One of the supporting roof beams was also cracked at the shear zone near the column support. See Photo No. 5. Some of the concrete resting shelter structures have shown signs of damage at the concrete column support due to the force of earthquake. Cracks have developed and portions of each column have spalled. See Photo No. 6 and 7. Other concrete structures damaged as a result of recent seismic activities are the concrete pedestals at one of the resting areas near the beach. Such failure is apparently the result of combined rusting of the reinforcing bars and ground motion from the earthquake. See Photo No. 8 and 9.

Photo No. 2- Upper toilet and restroom building.

Despite the damages identified above, the general condition of these structures was fair. The reported damages must be repaired as soon as possible to prevent further deterioration of the structural systems of each unit. We anticipate the cost of repair at approximately \$200,000 and a period of construction of 4 months.

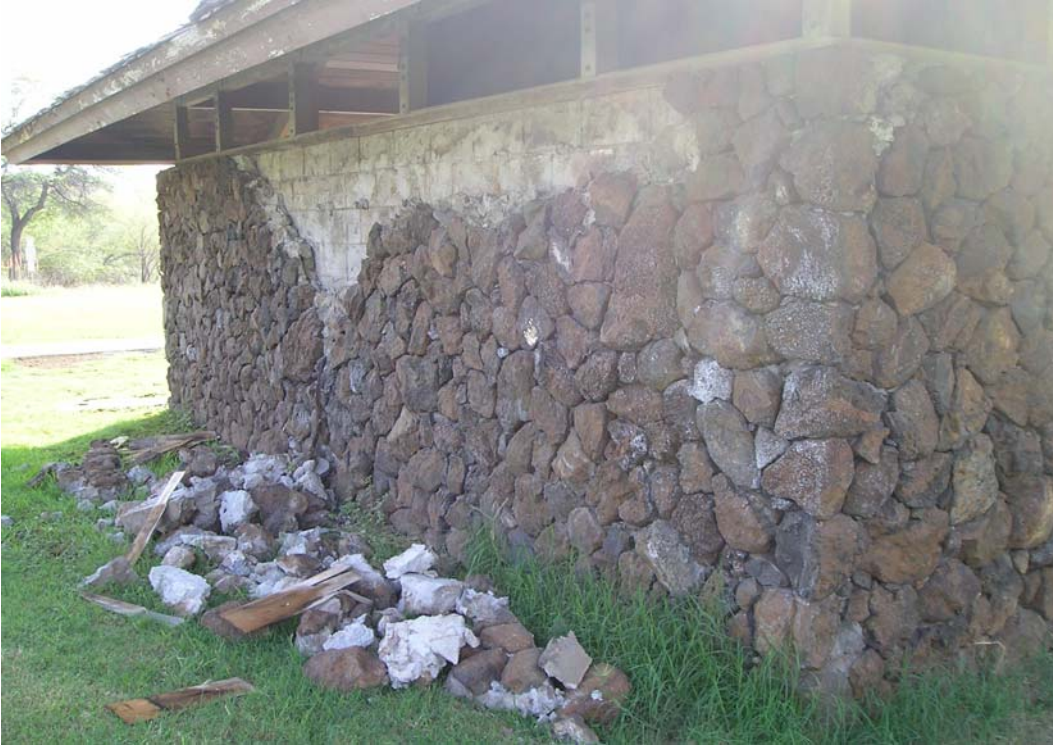
Photo No. 3- Rock wall venire damaged due to earthquake.

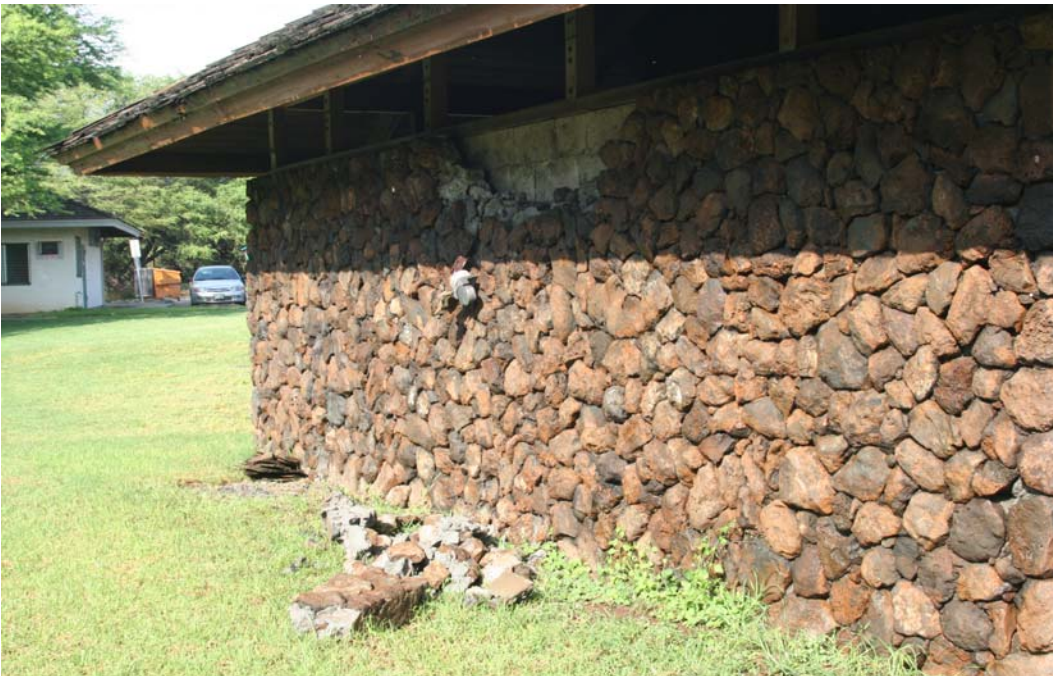
Photo No. 4- Rock venire damage caused by ground shaking.

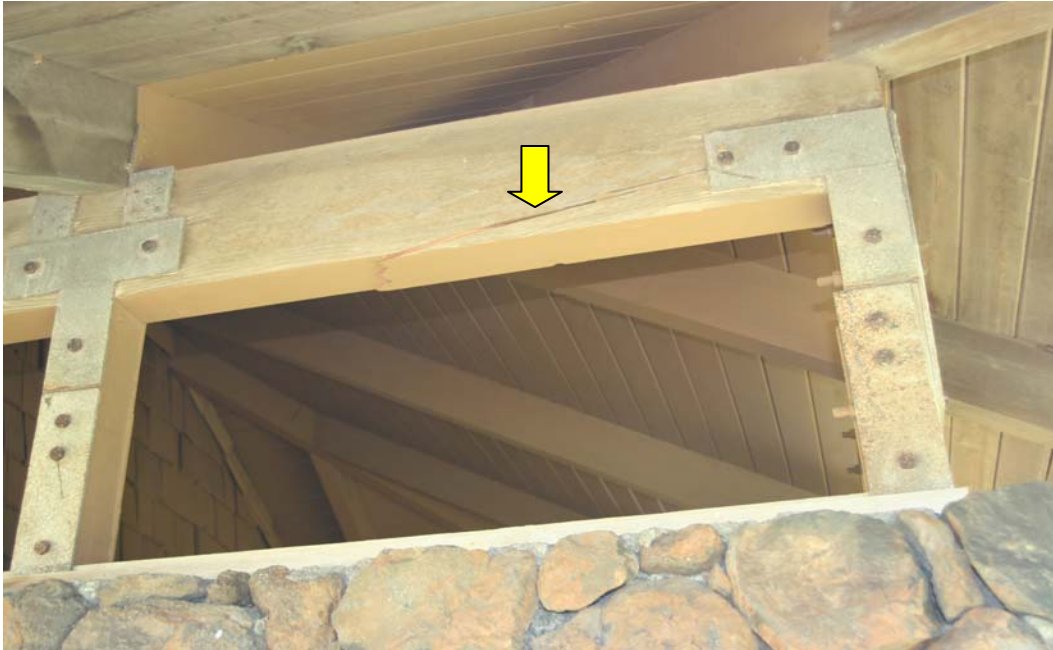
Photo No. 5- Perimeter support beam cracked at shear zone.

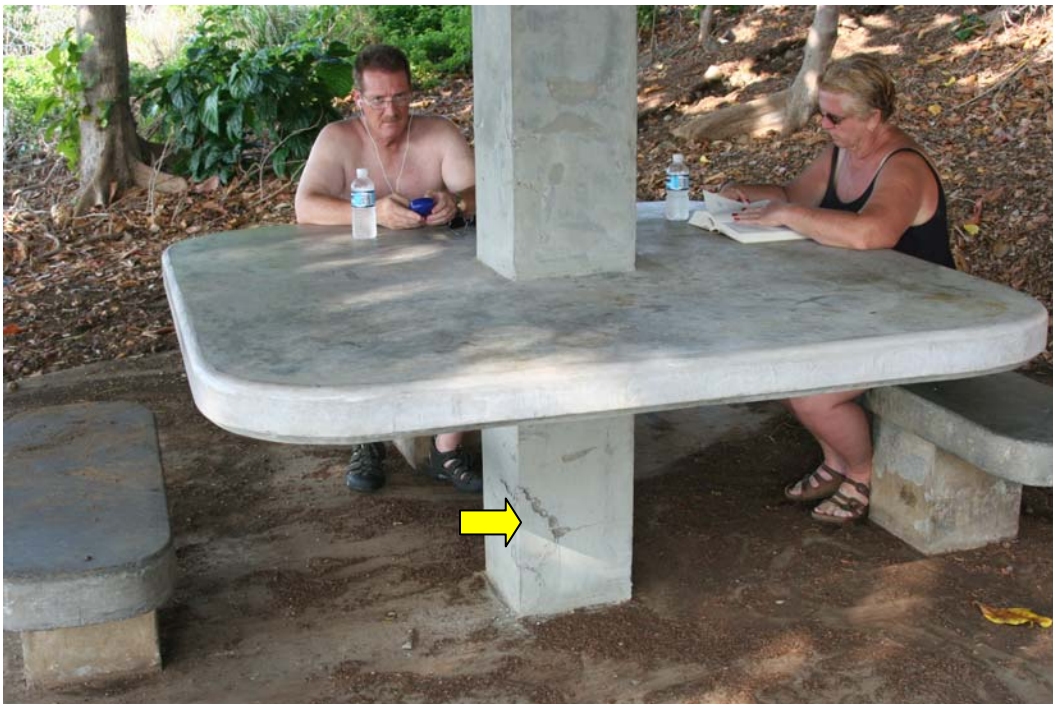
Photo No. 6- Damage to the concrete column at its base with sporadic cracking.

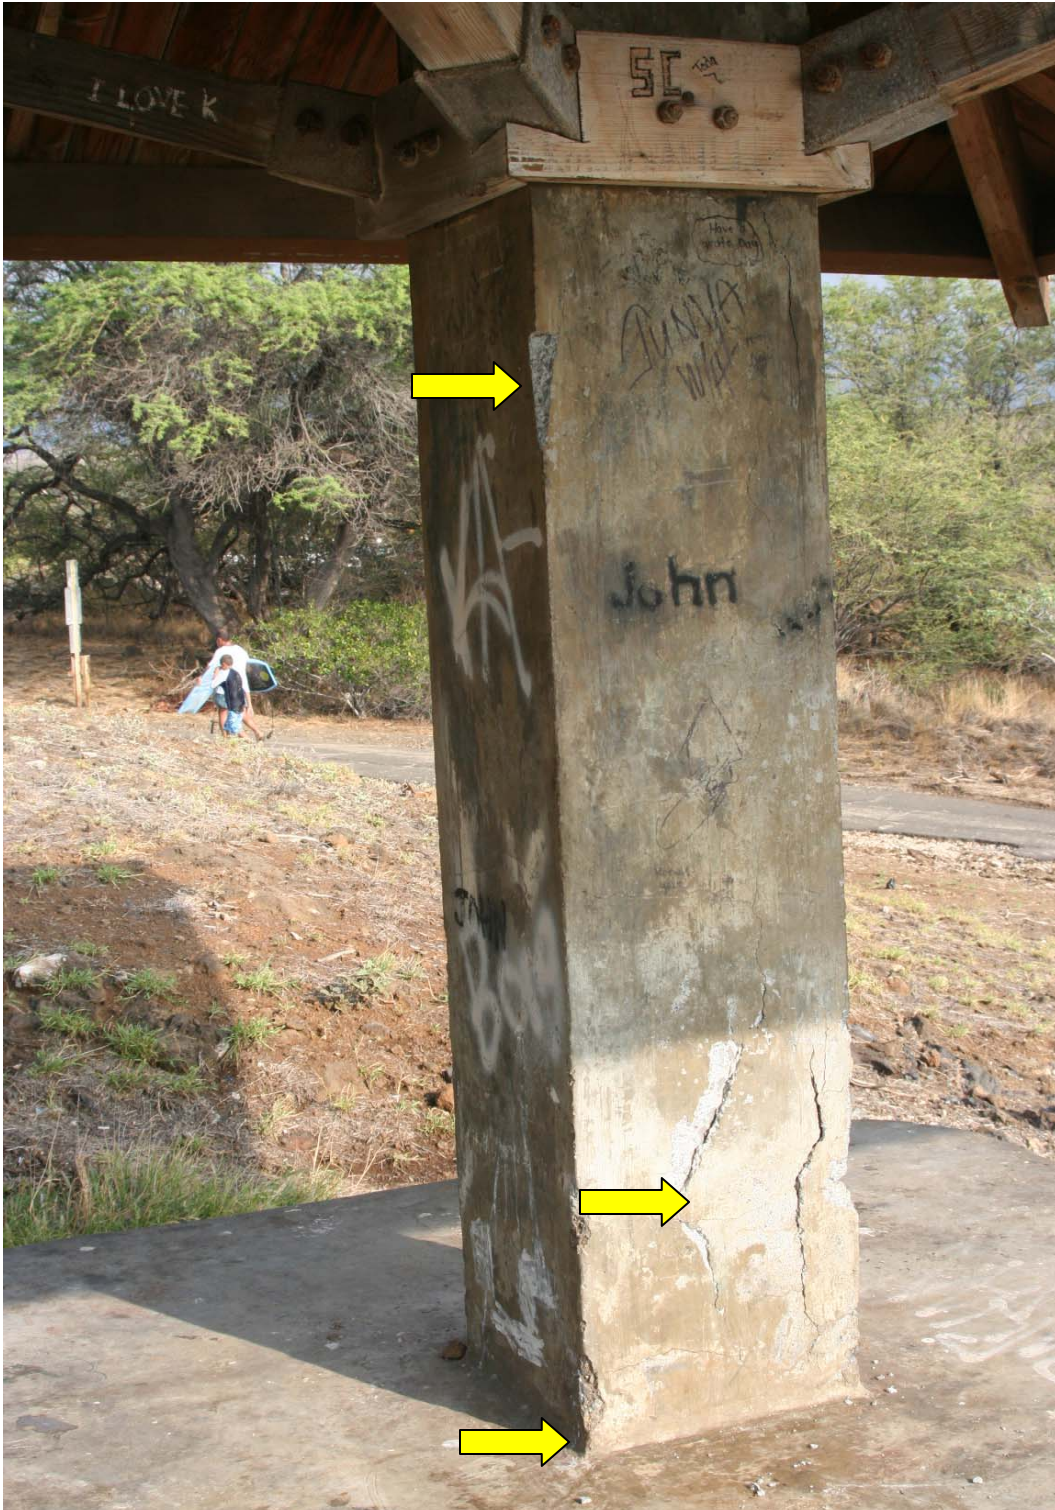
Photo No 7- Cracking and spalling of concrete support column.

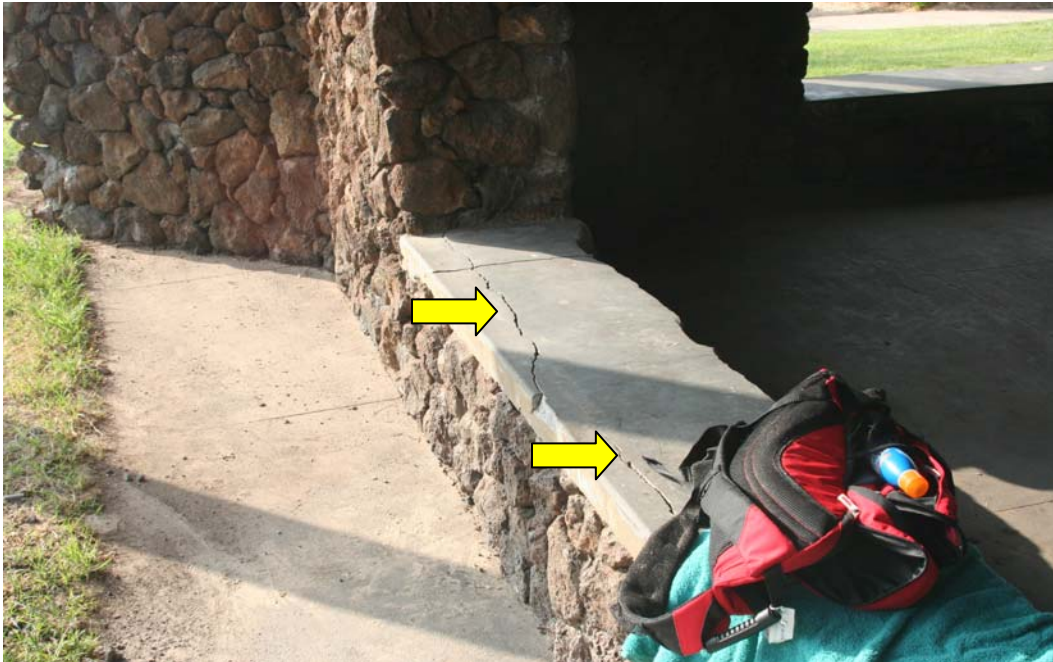
Photo No. 8- Cracks in concrete pedestals due to combined rusting of rebars and earthquake.

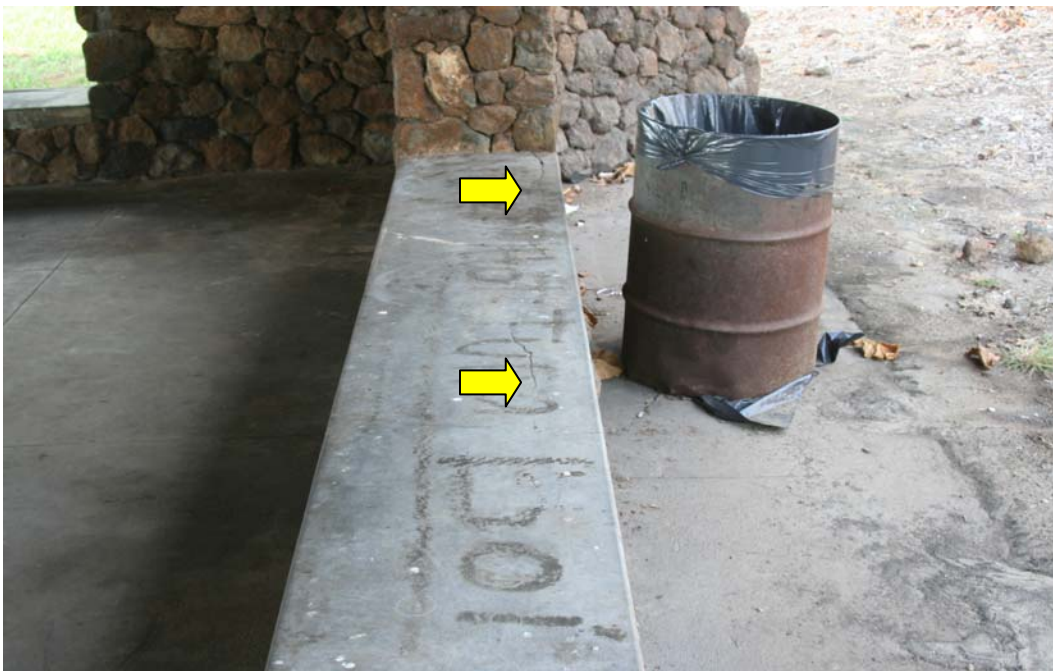
Photo No. 9- Cracks in concrete pedestal.

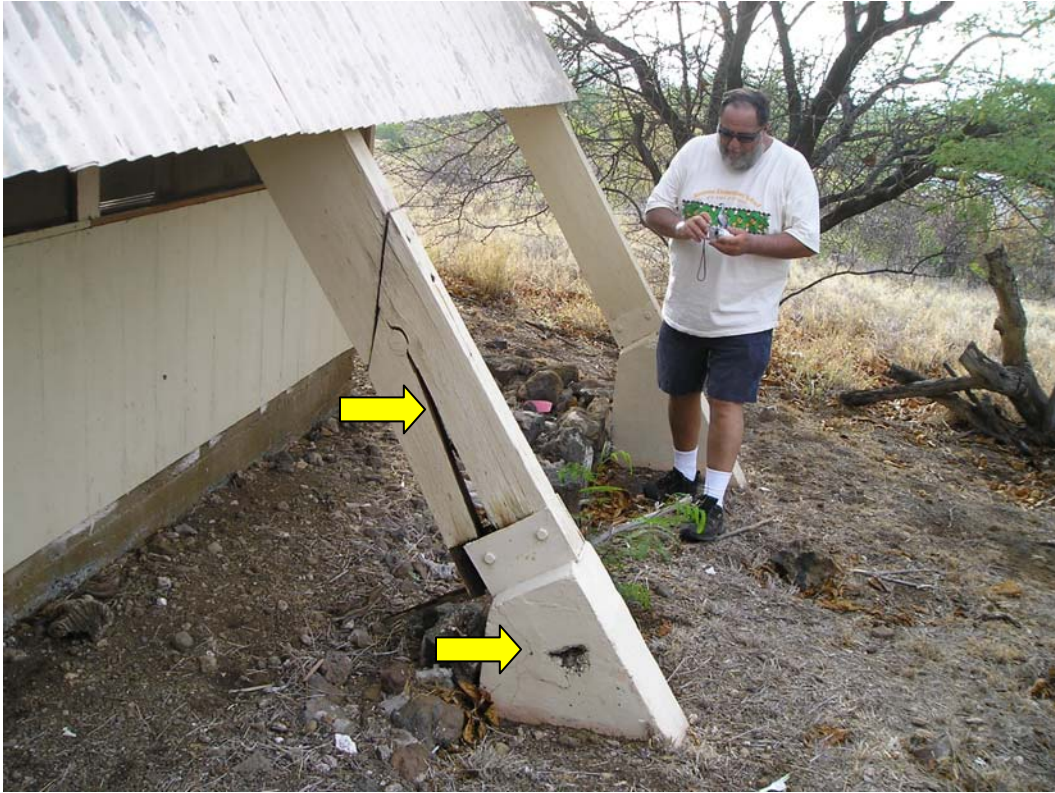
A small rental cabin with reported damage was inspected. The cabin is located on the east end of the State Recreational Area. The building structure is of A-frame timber construction, and except for one of the rafters and its concrete support

foundation blocks, it appeared to be in a fair operating condition. See Photo No. 10.

Photo No 10- Cracking of the main roof rafter and concrete support.
